# Manhole Inspection Summary

Manhole # S37CC1022MH

Insp Date: **12/8/06 11:27 AM**

**Location** Address: **3524 GREENMOUNT AVE**

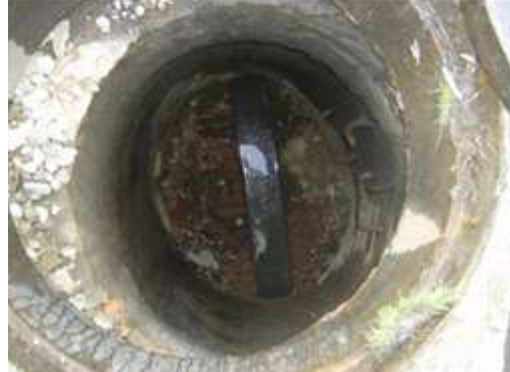
Top View

Corroded and missing steps. Evidence of surcharge - Bench debris. Channel debris.

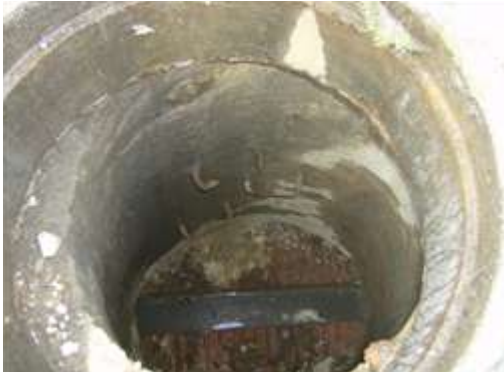
Defect

Frame leaks. Frame offset. Adjustment deterioration and infiltration. Barrel infiltration - other side.

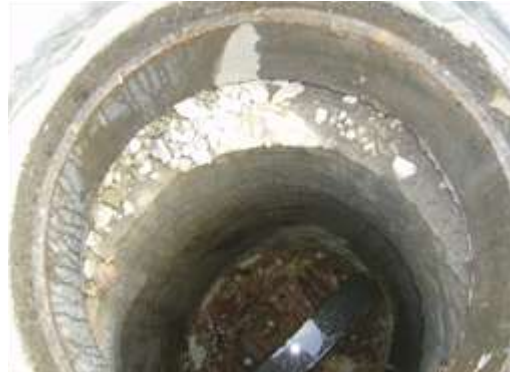
Defect

Frame leaks. Frame offset. Adjustment deterioration and infiltration. Barrel infiltration.

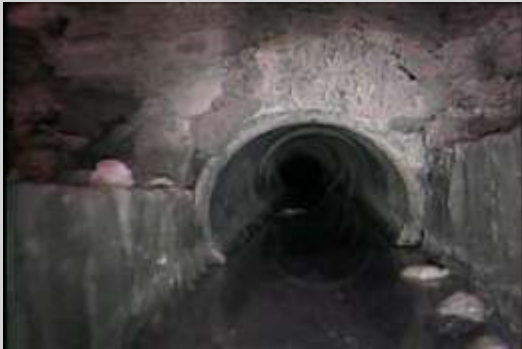
### 8 in. Circular Gravity Sewer Pipe Out @ 12 O'Clock

Deposits: ☐ None ☒ **Mud** ☐ Sludge ☒ **Debris** ☐ Grease

Silt Depth: **0** (in.) Deposits Extent: **Light**

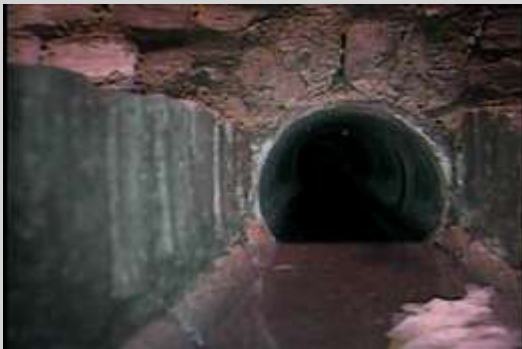
### 8 in. Circular Gravity Sewer Pipe In @ 6 O'Clock

Deposits: ☐ None ☒ **Mud** ☐ Sludge ☒ **Debris** ☐ Grease

Silt Depth: **0** (in.) Deposits Extent: **Light**
